STRESS CORROSION CRACKING OF ROCK BOLTS

Erwin Gamboa

A THESIS SUBMITTED TO THE UNIVERSITY OF QUEENSLAND
FOR THE DEGREE OF DOCTOR OF PHILOSOPHY

NOVEMBER 2004

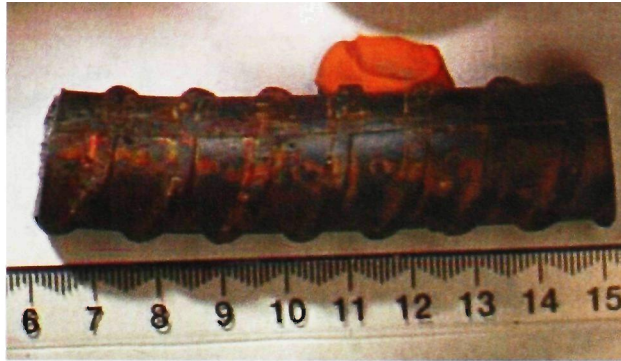
Figure 5.1 presents a macroscopic view of the rock bolt. Figure 5.1 shows the curvature of the bolt caused by shear in the rock strata. The bolt was no longer straight and parallel to the straight edge also shown in the Figure. The fact that the bolt was in a bent condition indicates that there had been a bending moment on the bolt in service and that this bending moment had caused stresses on the bolt. Furthermore, these stresses exceeded the yield stress as was evident by the permanent (plastic) change of shape of the bolt. This bending was attributed to horizontal shear in the rock strata in which the bolt was operating. These shear stresses would add to the tensile stresses that were estimated from the plastic deformation of the support plate. The fracture surface was at the left end of the bolt segment. This fracture was macroscopically brittle. There was no evidence of any plasticity. This was unusual, because there was lots of plasticity if the bolt was caused to fail by increasing the stress until the stress exceeded the ultimate tensile stress. Under such conditions, there was lots of plasticity and the bolt necked down significantly. Such tensile testing has been carried out on such bolts failed in service and has produced normal ductile failure. Thus, Figure 5.1 presented a brittle failure of a bolt at a stress much lower than its ultimate tensile stress.

Rock bolts [6] provide a cost efficient roof support system. Rock bolts have provided good service [6]. Rock bolts are made from ductile steel and do not usually fail in service in a brittle manner. However, Figures 5.1 and 5.2 indicate brittle failure for this particular rock bolt. Furthermore, the deformation of the support plate indicated that the service load was below the yield load. The local mine environment was described as "dry". This description of a dry local environment was consistent with the overall bolt appearance, Figure 5.1, which showed little corrosion. However, it was unlikely that there was no water at all in the mine. Coal mines are typically moist, and it is not uncommon to have significant water percolating through the rock

FIGURE 5.1: Macroscopic view of colliery A rock bolt. The fracture was at the left end of the bolt segment

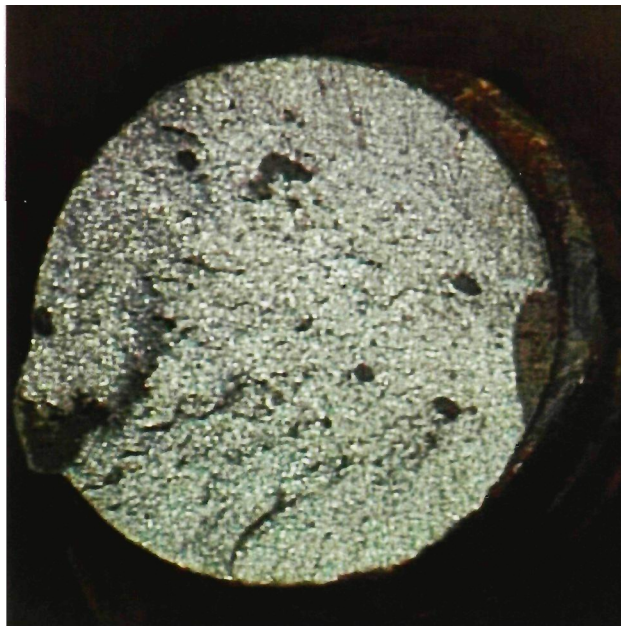
Figure 5.2 presented an overview of the fracture surface. The most striking feature was the dark thumbnail shaped area on the right of the bolt, near the rib. The rest of the fracture surface was quite shiny and irregular, speckled by dark areas. These dark areas were deposits of carbon/coal on the fracture surface. This combination of a dark thumbnail area together with the shiny surface, as well as lack of necking in the bolt, suggested that the bolt had failed by Stress Corrosion Cracking (SCC). The dark thumbnail area was where the stress corrosion crack initiated and grew slowly until the stress corrosion crack reached a critical size. Once this size was reached, the bolt failed instantaneously in a brittle manner, producing the shiny irregular surface. The diameter of the rock bolt was 21.5 mm, corresponding to an area of 363 mm^2 . The thumbnail area was 6.6 mm long by 1.9 mm at its widest point, covering an area of approximately 7 mm^2 . This corresponded to 1.9% of the total fracture area. Examination of the rock bolt indicated another phenomena that supported the theory that the bolt failed by SCC: secondary cracks. Due to the slow process of crack initiation and growth, it is not uncommon to find secondary cracks that did not grow to a size sufficient to initiate fast fracture. These secondary cracks were 7.5 mm from the crack initiation site, on the other side of the rib. Figure 5.3 shows a close up view of the secondary cracks. Another feature of these cracks was that they did not line up. They were all along the foot of the rib, but they were inclined at about 30° from the rib foot direction. If the rock bolt had failed along the plane of the secondary cracks, it would have looked like one of the bolts received from colliery A. Figure 5.4 shows the stepped fracture surface on the left of the picture, caused by the secondary cracks joining during fracture.

FIGURE 5.2: Overview of fracture surface

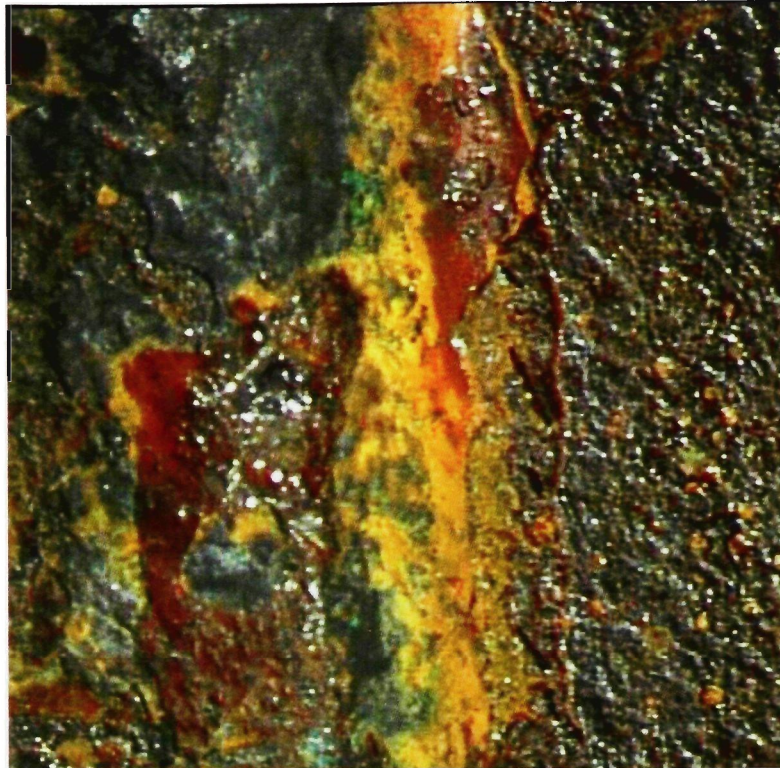
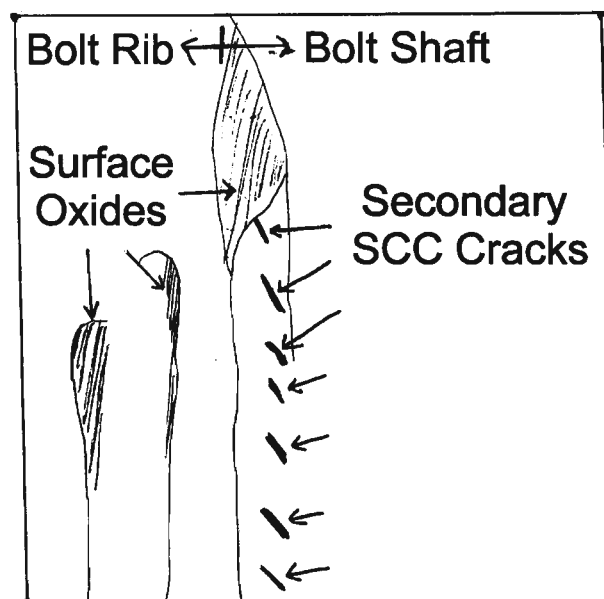
(a) View of secondary cracks

(b) Schematic view showing the SCC secondary cracks along the foot of the rib. The tensile direction was the horizontal plane (sideways)

FIGURE 5.3: SCC secondary cracks

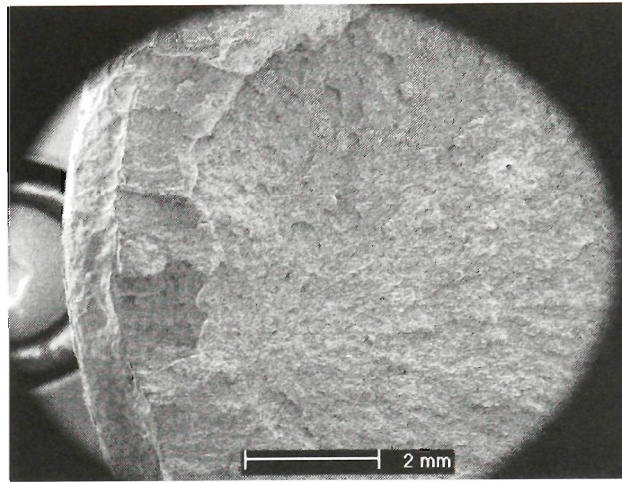
FIGURE 5.4: Stepped fracture surface of rock bolt from colliery A.

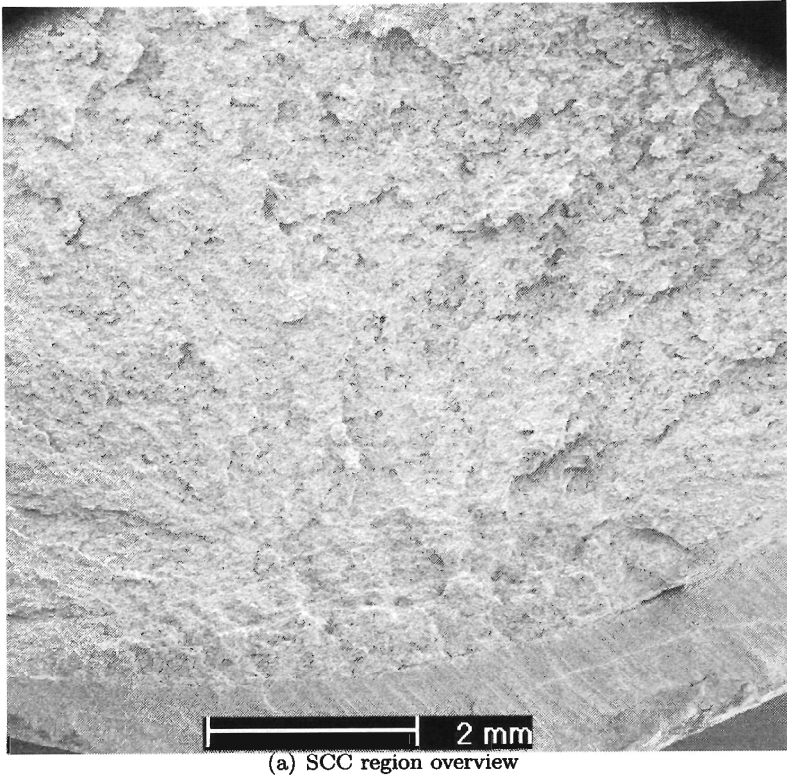
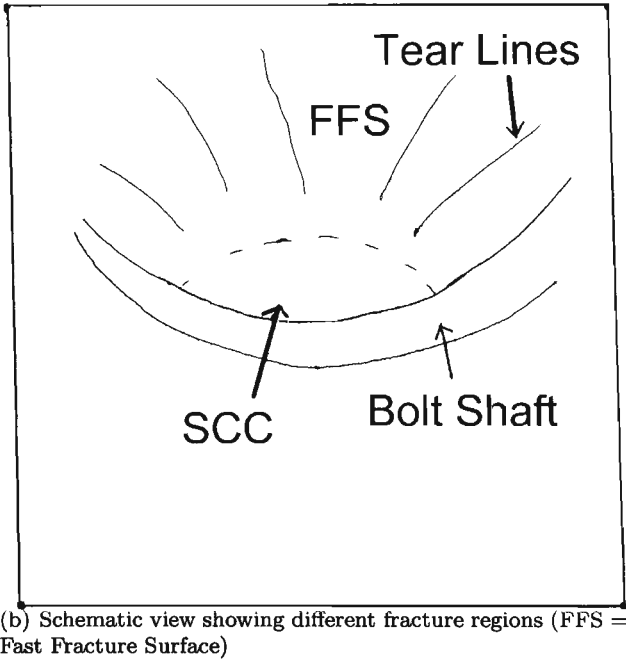
Figure 5.5 shows an overview of the SCC region. This indicated a thumb nailed SCC region and a Fast Fracture Surface (FFS) as shown schematically.

FIGURE 5.5: SCC region overview

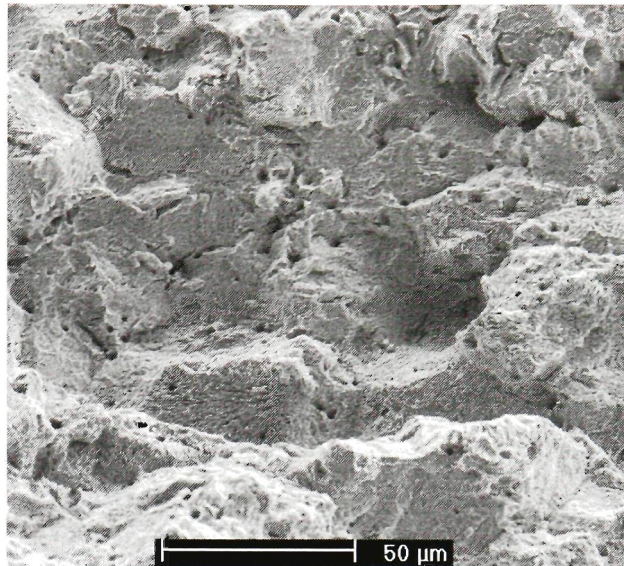
Figure 5.6 shows the fracture surface at the edge of the rock bolt at the crack initiation site. The main characteristic of this fracture surface was a porous network of branched channels. Such channels sometimes ran parallel, other times their direction appeared to be random. This fracture surface appeared to consist of minuscule shelves, which were porous. Such characteristic fracture surface has been seen in other samples obtained from service as well as laboratory samples.

FIGURE 5.6: SCC region detail

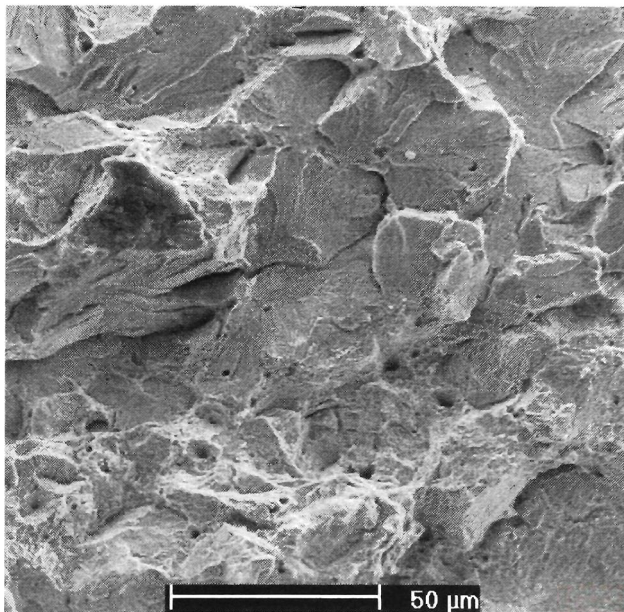
Figure 5.7 shows the boundary where the fracture mechanism changed from slow crack growth (bottom) to fast brittle fracture (top). A close examination revealed that the change of mechanism was sharp, indicating that there was no third mechanism involved during the fracture.

FIGURE 5.7: SCC - fast fracture interface

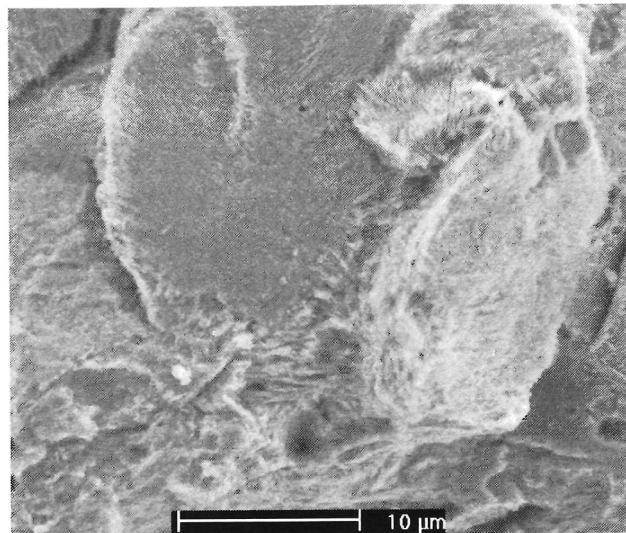
Figure 5.8 shows a metal grain where the fracture mechanism changed. On the lower section of this grain is the SCC surface.

FIGURE 5.8: Detail of Figure 5.7

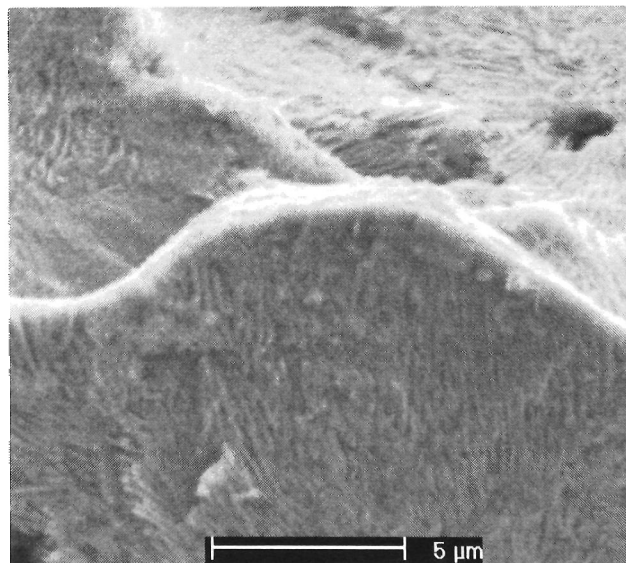
The fast fracture surface was typical of fast brittle fracture, and was similar to those of other rock bolts and of the laboratory samples. Figure 5.9 shows that the fast fracture surface was not smooth at this high magnification; there were ridges on the flat surfaces approximately 200 nm apart. These were attributed to the pearlite microstructure (alternating bands of ferrite and cementite).

FIGURE 5.9: Very high magnification view of fast fracture surface

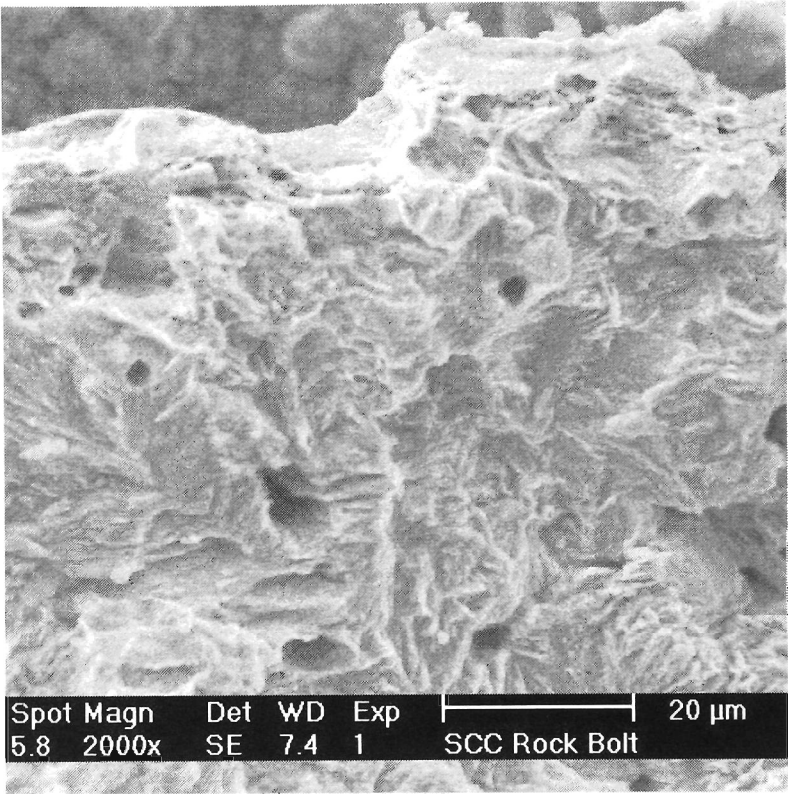
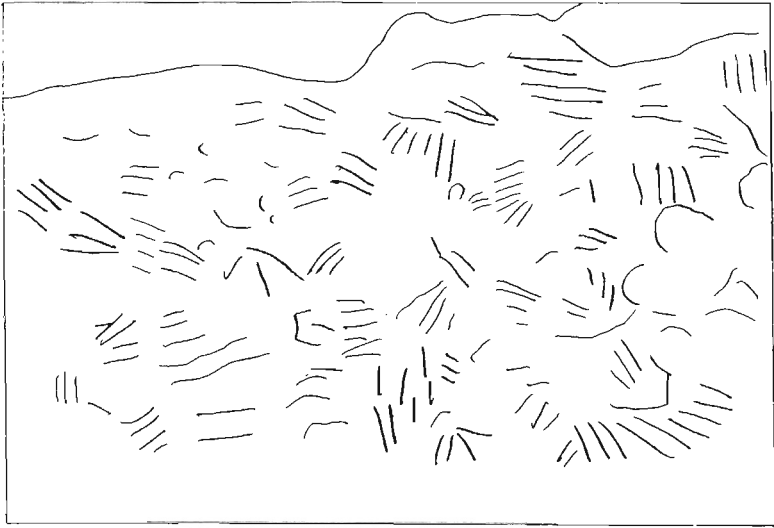
(a) Rock bolt TTS region.

(b) Schematic view showing rock bolt TTS ridge orientation

FIGURE 5.11: Rock bolt TTS region

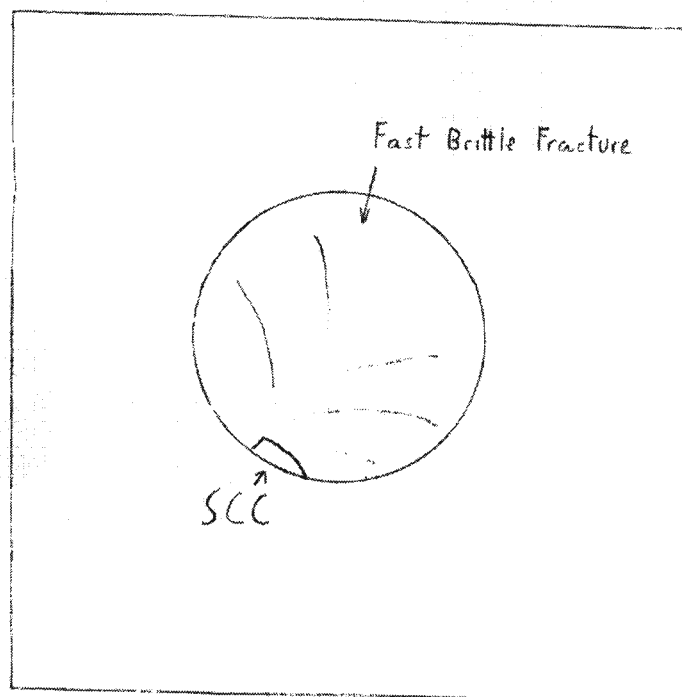
Figure 5.13 shows the fracture surface of the rock bolt. The bolt was received with its fracture surface damaged in several areas. Although the macroscopic photograph shows much carbon deposits on the surface of the bolt, most could be washed away during preparation for SEM observation.

(a) Macroscopic view of the bolt's fracture surface

(b) Schematic view showing SCC and fast fracture areas

FIGURE 5.13: Rock Bolt fracture surface

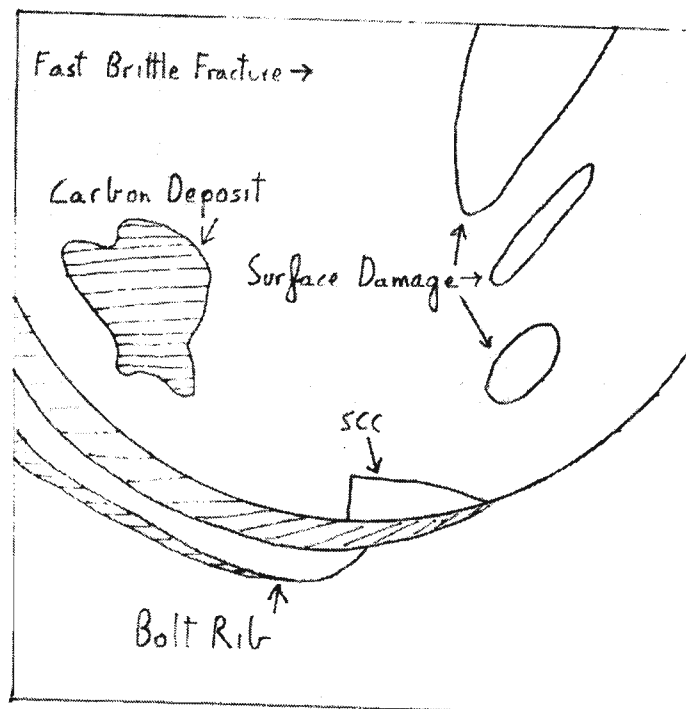
(a) Higher magnification view of the bolt's fracture surface

(b) Schematic view showing carbon deposits and surface damage

FIGURE 5.14: Rock Bolt fracture surface

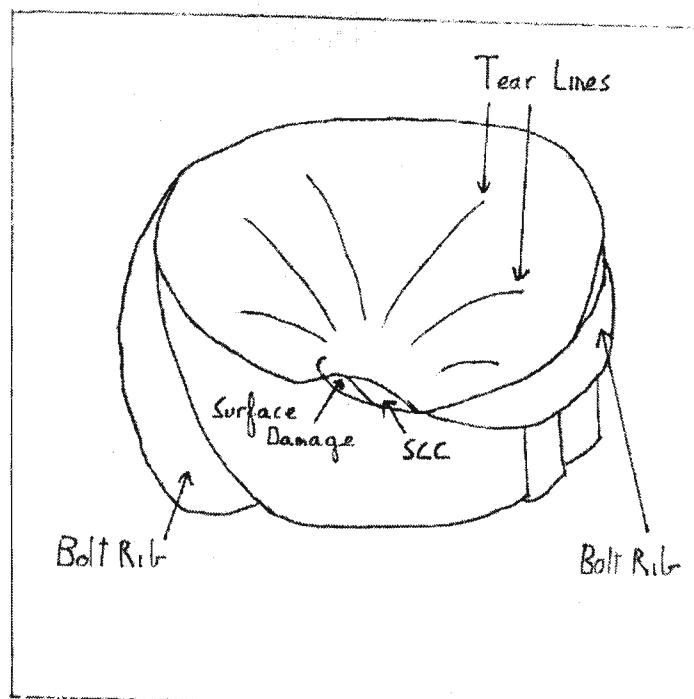
(a) High magnification photograph of the SCC area along the bolt rib

(b) Schematic view outlining SCC area, carbon deposits and surface damage

FIGURE 5.15: SCC along the foot of the bolt rib

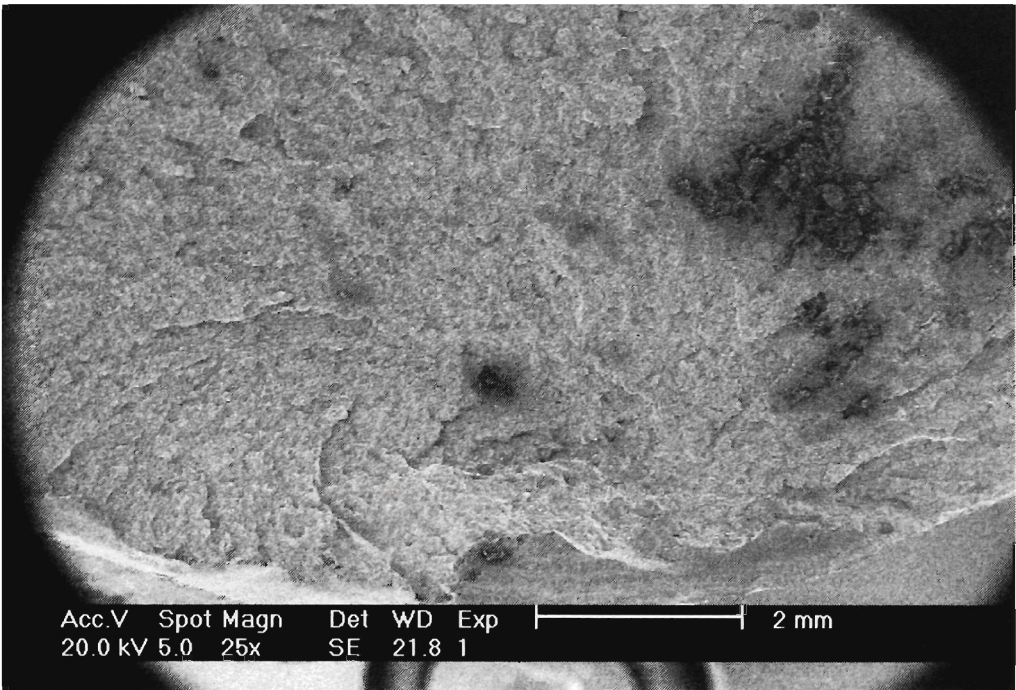
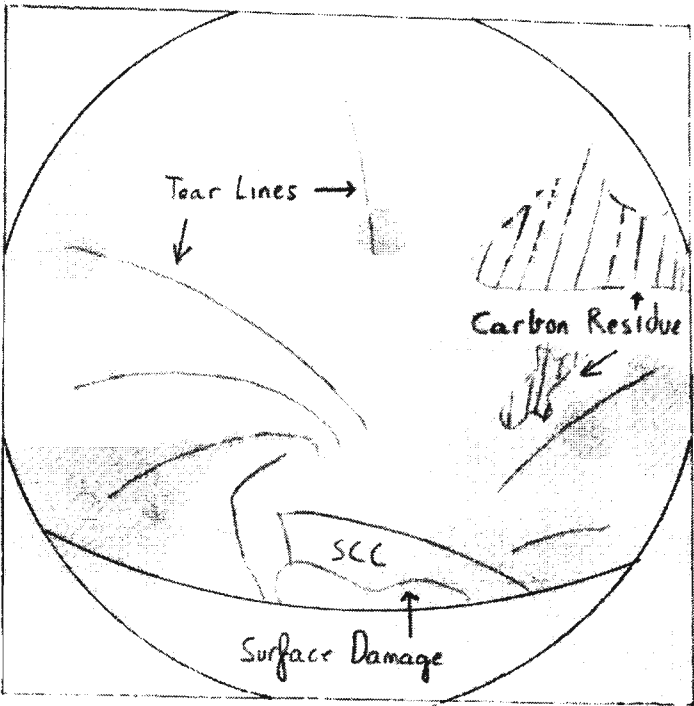
(a) Overview of SCC area

FIGURE 5.16: SCC overview

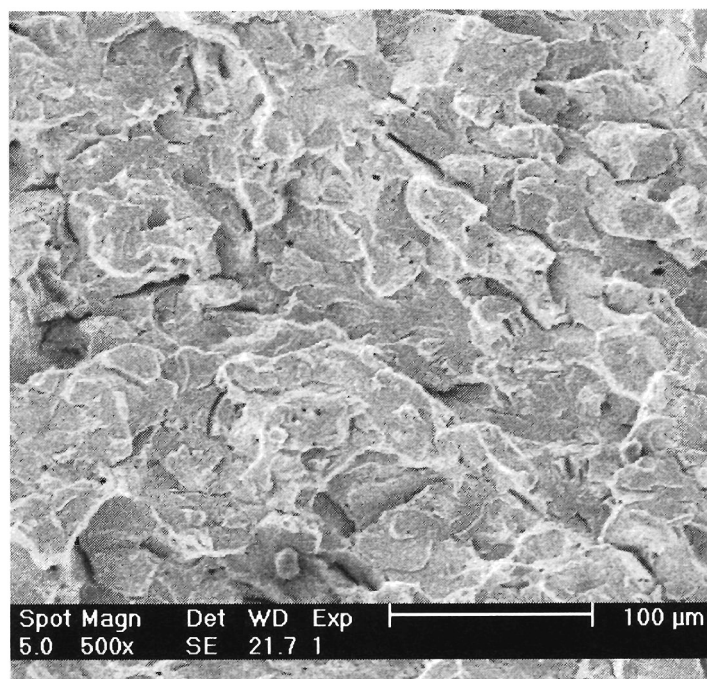
Fast Fracture Surface was made up of cleavage like fracture. The surface was made up of many facets which resembled maple leaves, growing in the direction of the final crack propagation. This surface was produced by the brittle catastrophic failure of the bolt.

FIGURE 5.17: Typical Fast Fracture surface.

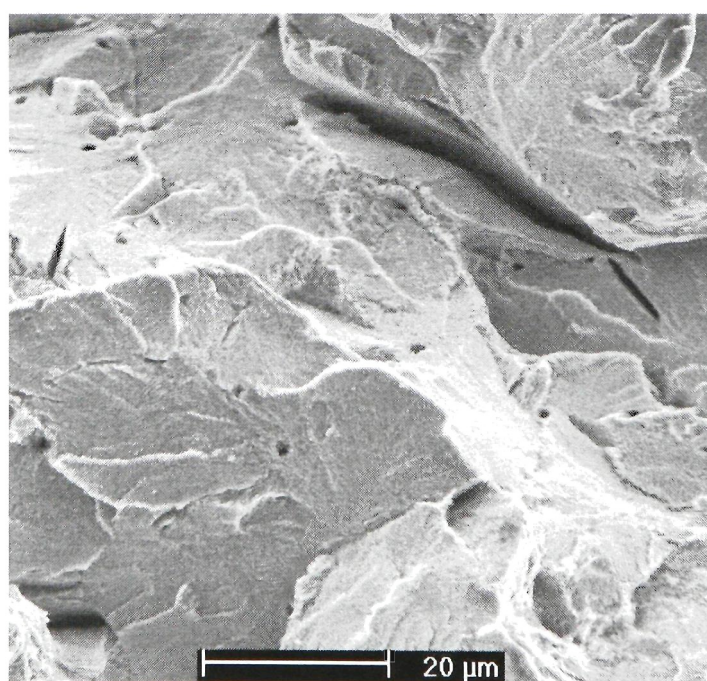
For comparison, Figure 5.18 shows the overload region in another rock bolt at a higher magnification. The same maple leaf appearance can be seen in both pictures.

FIGURE 5.18: Higher magnification of fast fracture in a different bolt.

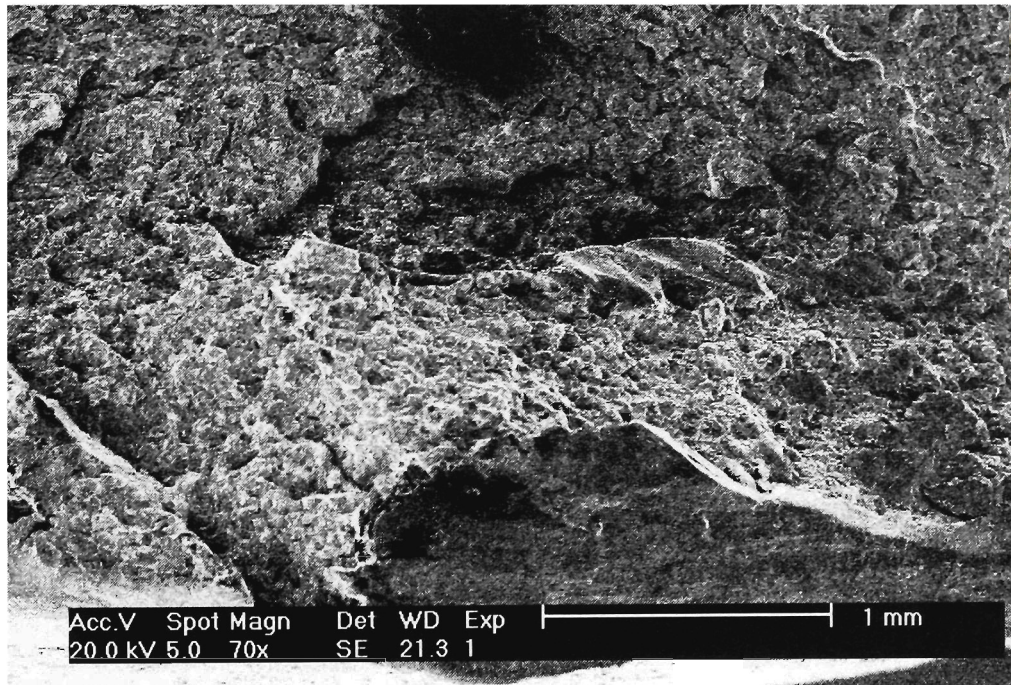
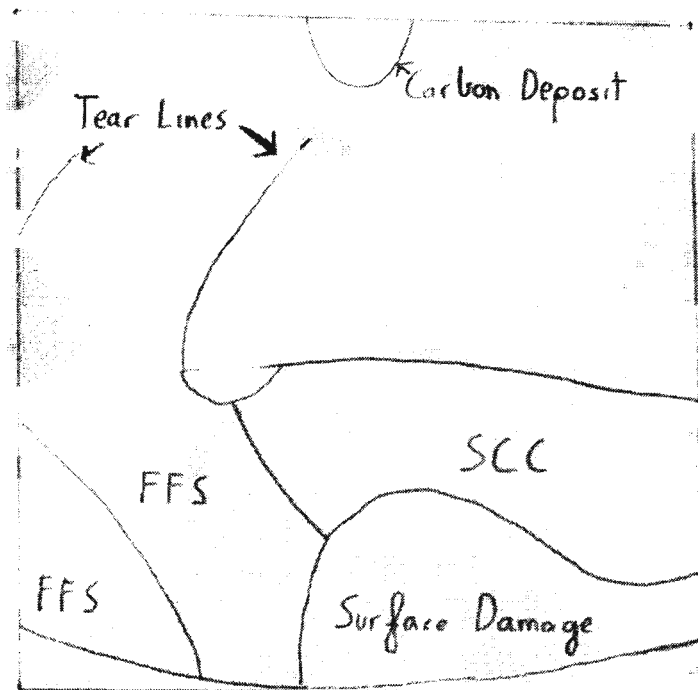
(a) Mosaic of SCC area

FIGURE 5.19: SCC overview

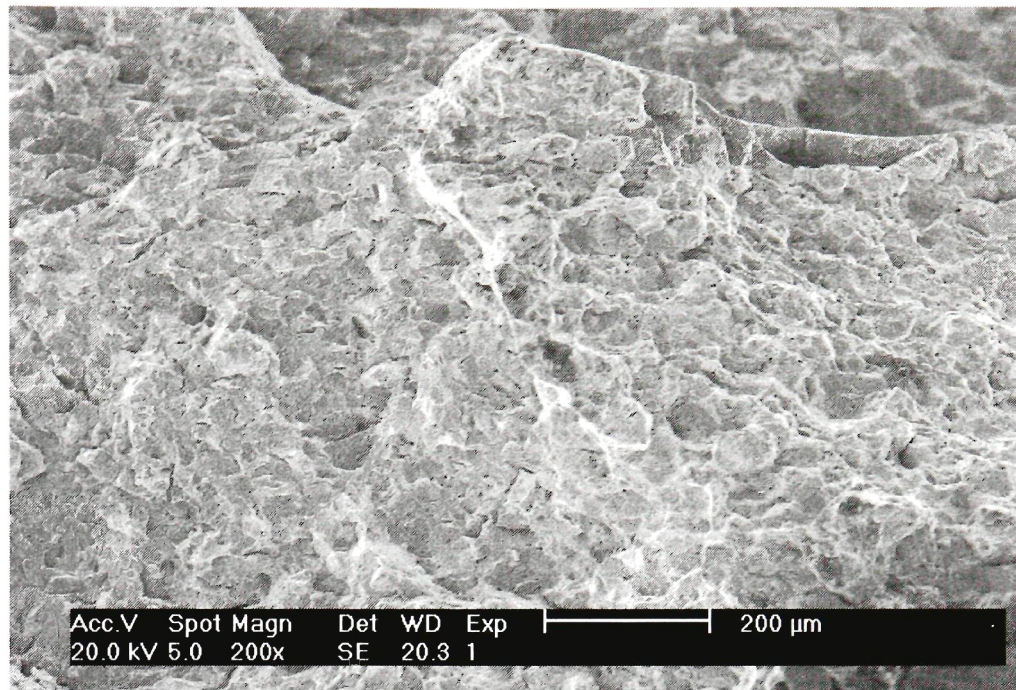
FIGURE 5.21: Fast brittle fracture interface with SCC.

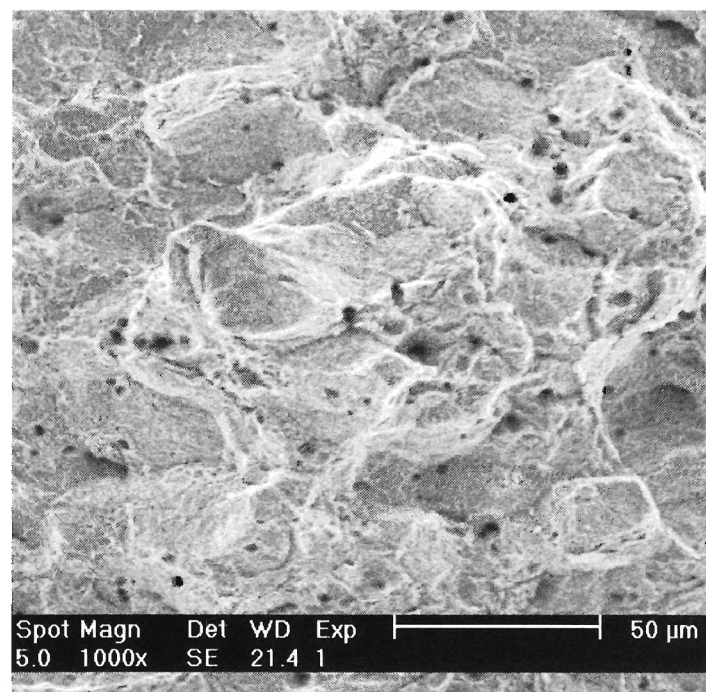
Figure 5.71 was taken from within the thumbnail shaped area close to the FFS. The Figure shows a typical Corrugated Irregular Surface (CIS) similar to other such surfaces which have been found in other rock bolts failed by SCC. Figure 5.22 shows a typical CIS surface in a different rock bolt. By comparing these Figures it can be seen that both bolts showed irregular surfaces. Both display the typical features of CIS (a network of branched porous channels on flat corrugated regions joined by steep corrugated slopes).

FIGURE 5.22: Typical SCC topography.

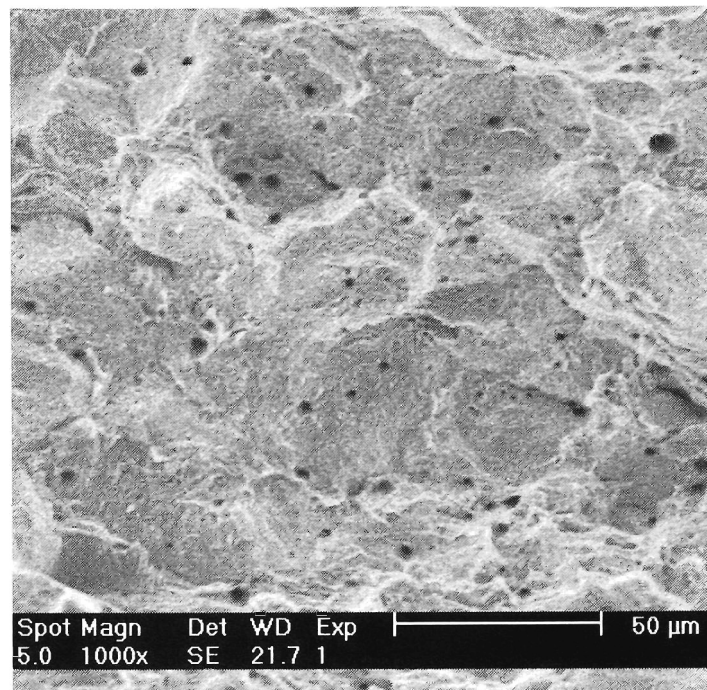
FIGURE 5.23: Typical SCC topography.

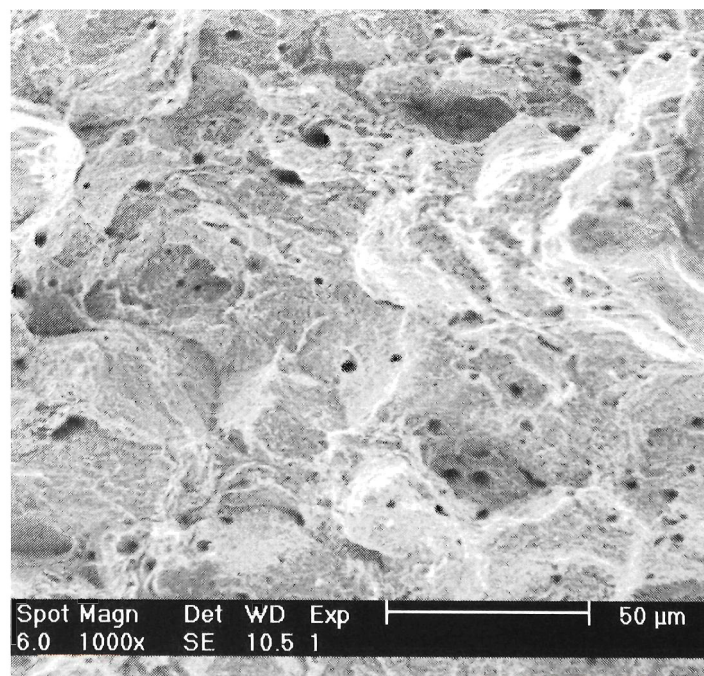
FIGURE 5.24: Typical SCC topography.

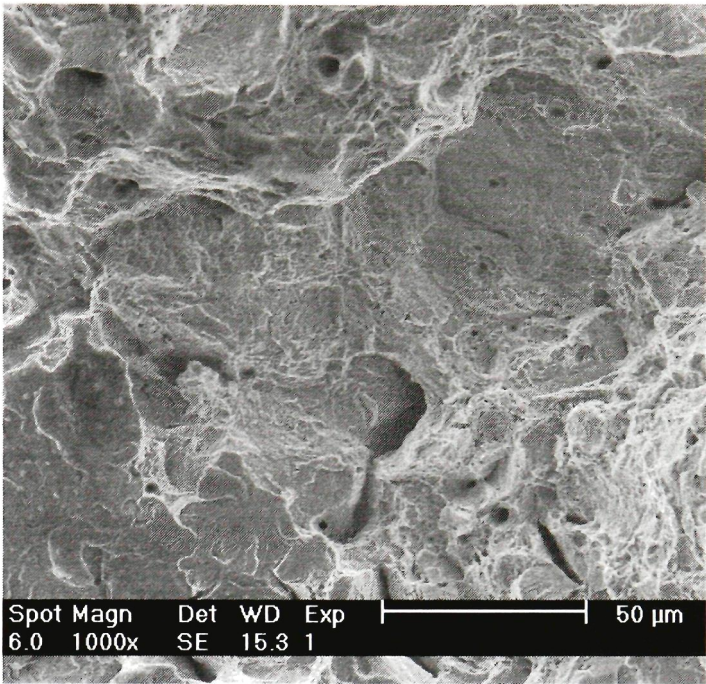
Similar fracture surfaces were also found within the SCC region in LIST laboratory samples, as seen in Figures 5.25 and 5.26.

FIGURE 5.25: SCC from sample LIST08. Fast Fracture region is on lower left, whilst SCC is on the upper right.

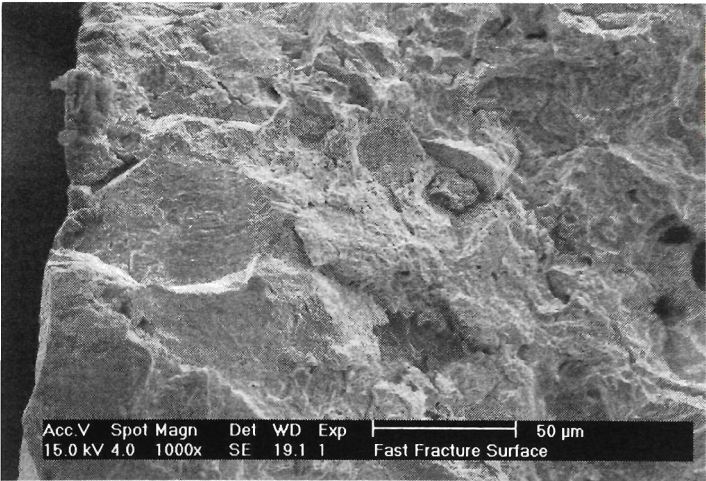
FIGURE 5.26: SCC region from sample LIST01

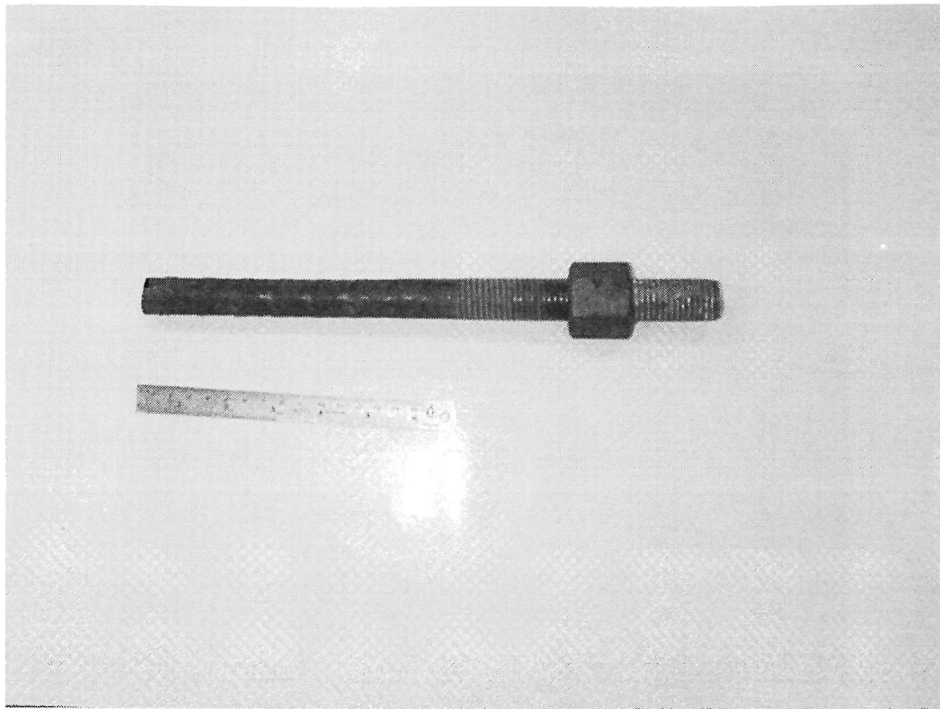
FIGURE 5.27: Overview of failed rock bolt

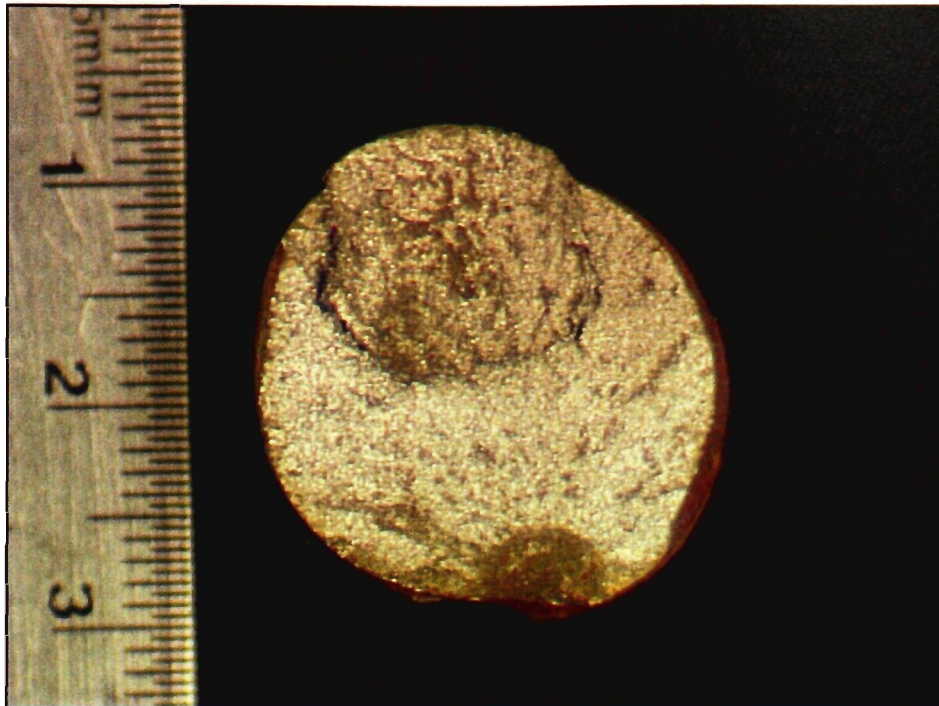
FIGURE 5.28: Macroscopic view of rock bolt's fracture surface

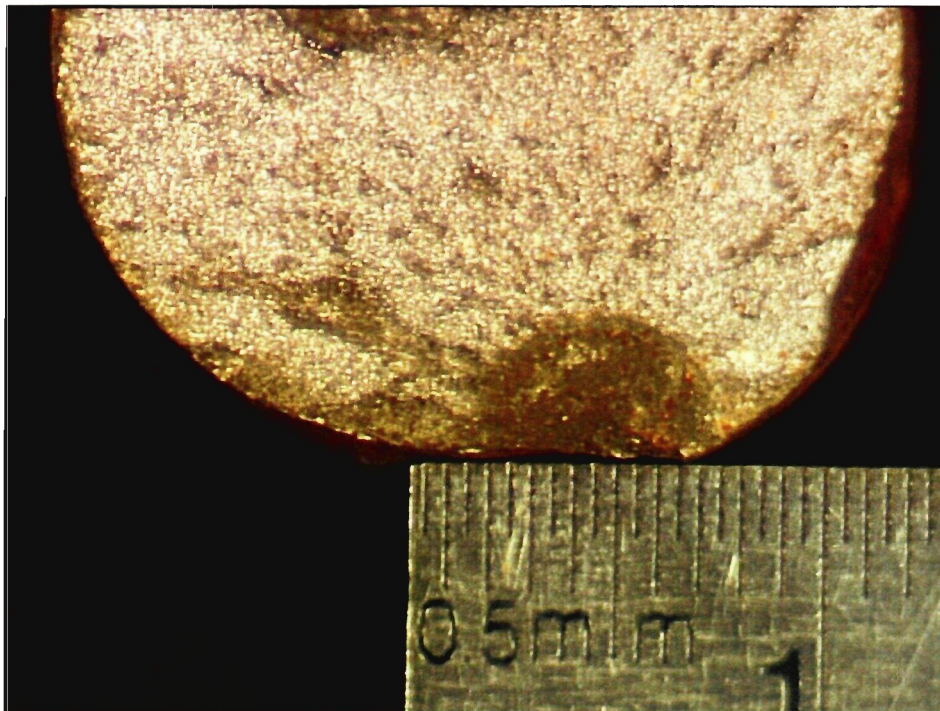
FIGURE 5.29: Macroscopic view of rock bolt's fracture surface at higher magnification

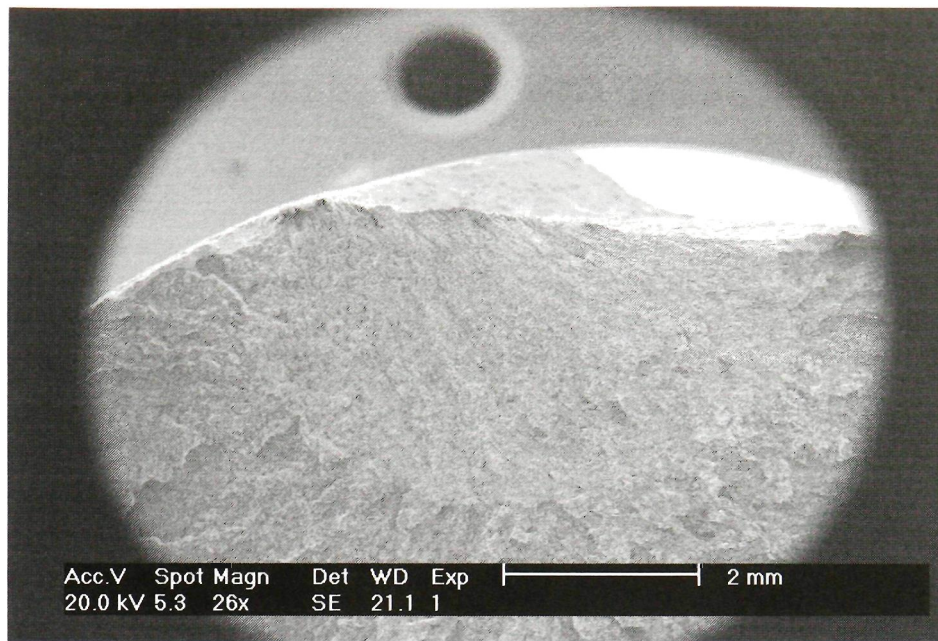
FIGURE 5.32: Overview of SCC region

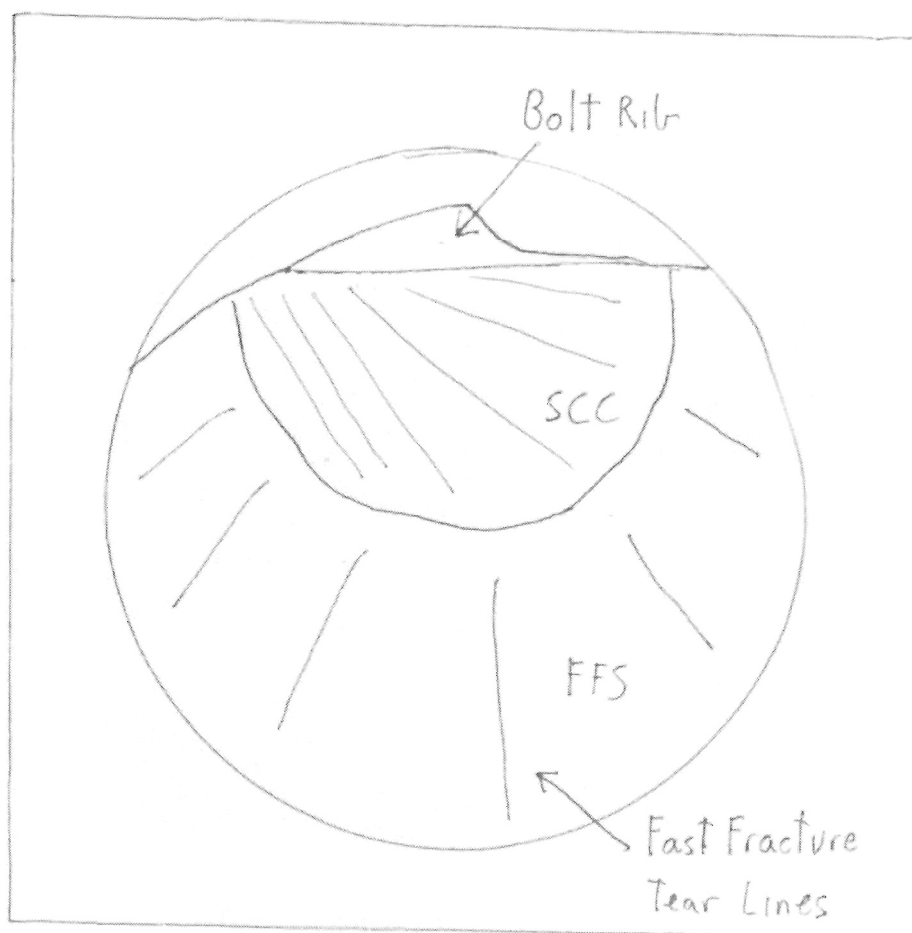
FIGURE 5.33: Diagram displaying overview of SCC region

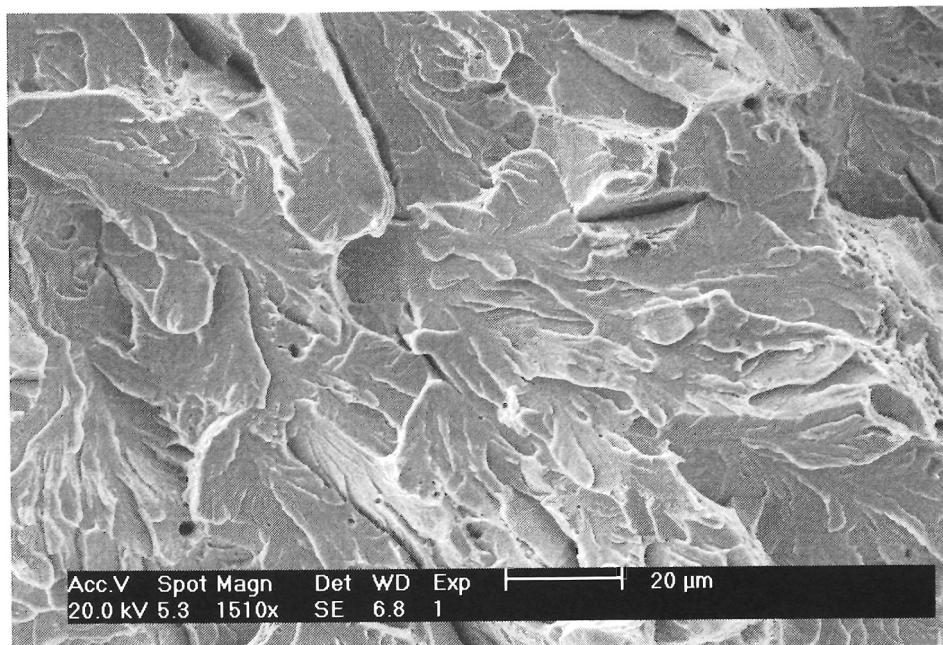
FIGURE 5.34: Fast fracture surface at x1510

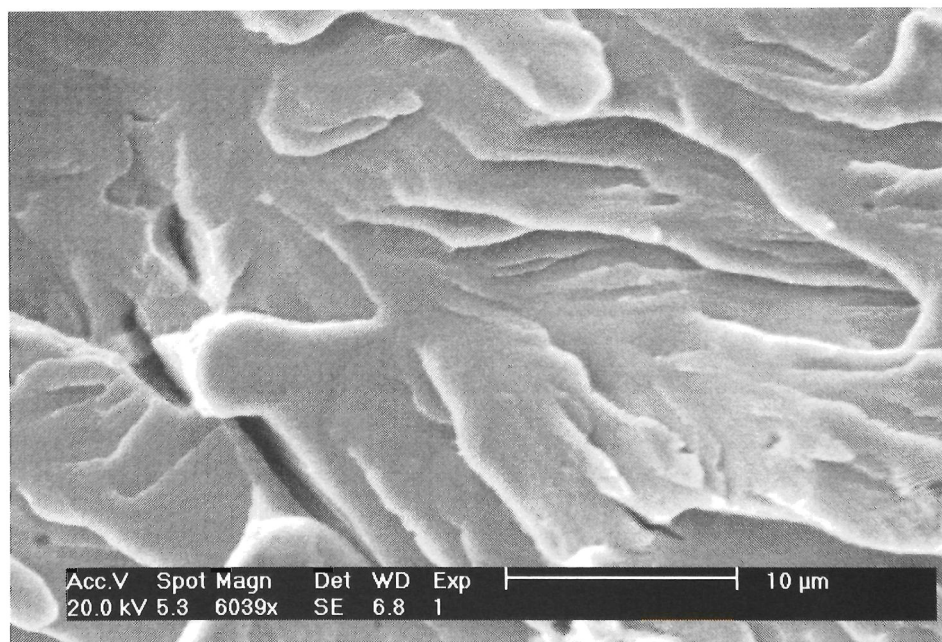
FIGURE 5.35: Fast fracture surface at x6039

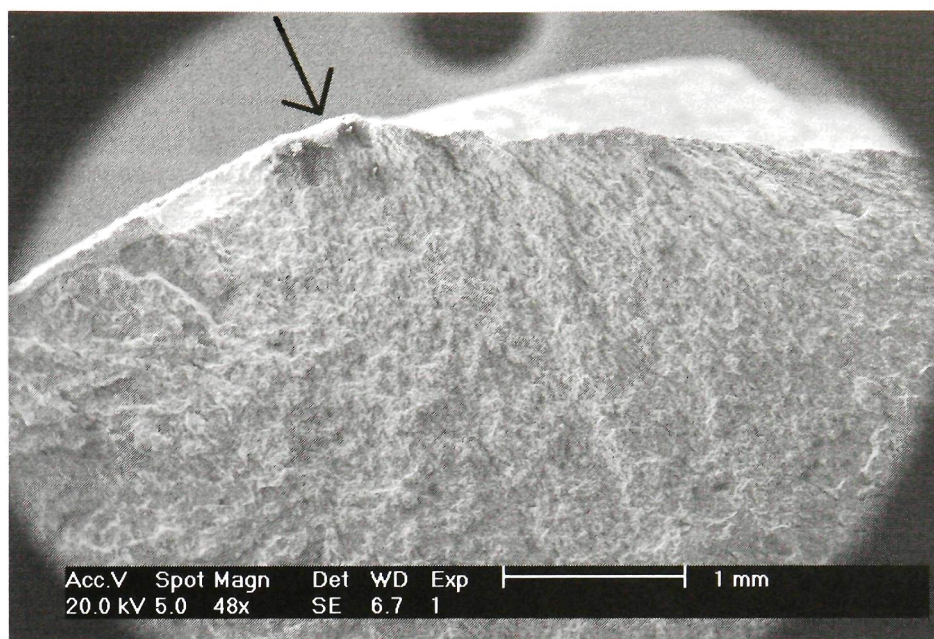
Figure 5.36 presents a detailed view of the thumbnail shaped area.

FIGURE 5.36: SCC overview. Arrow points to crack initiation site.

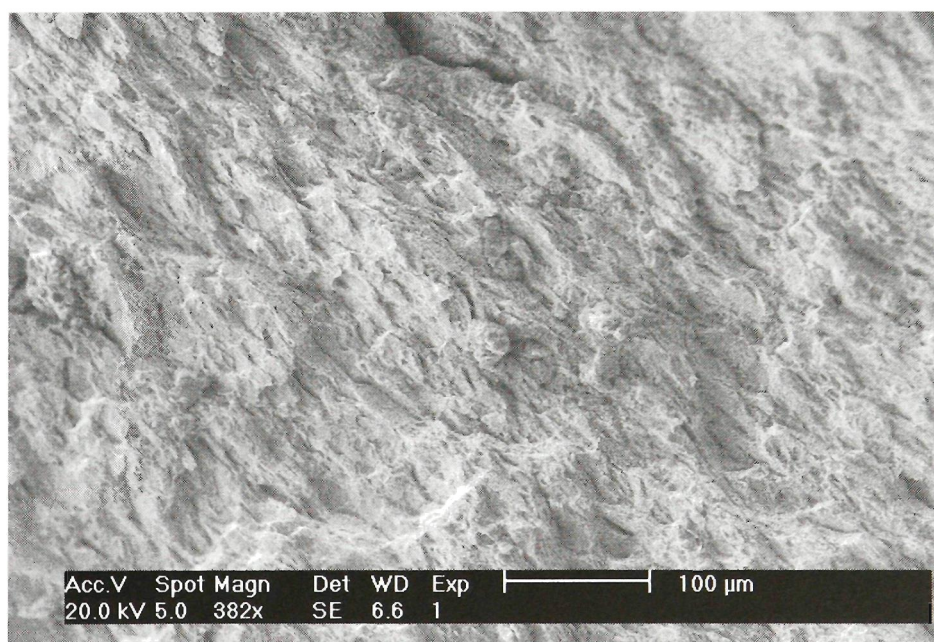
FIGURE 5.37: Detailed view of channels

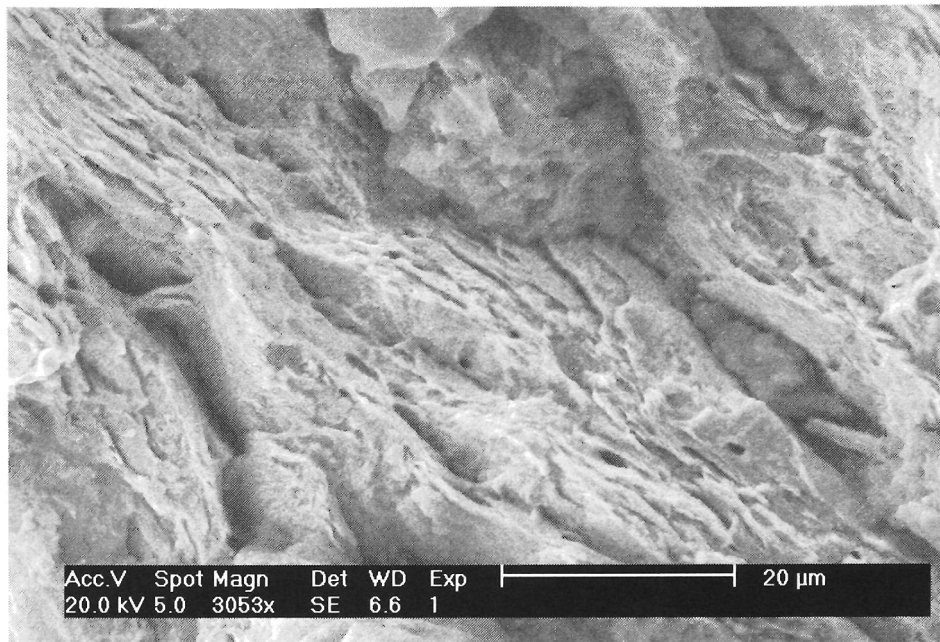
FIGURE 5.38: Detailed view of channels

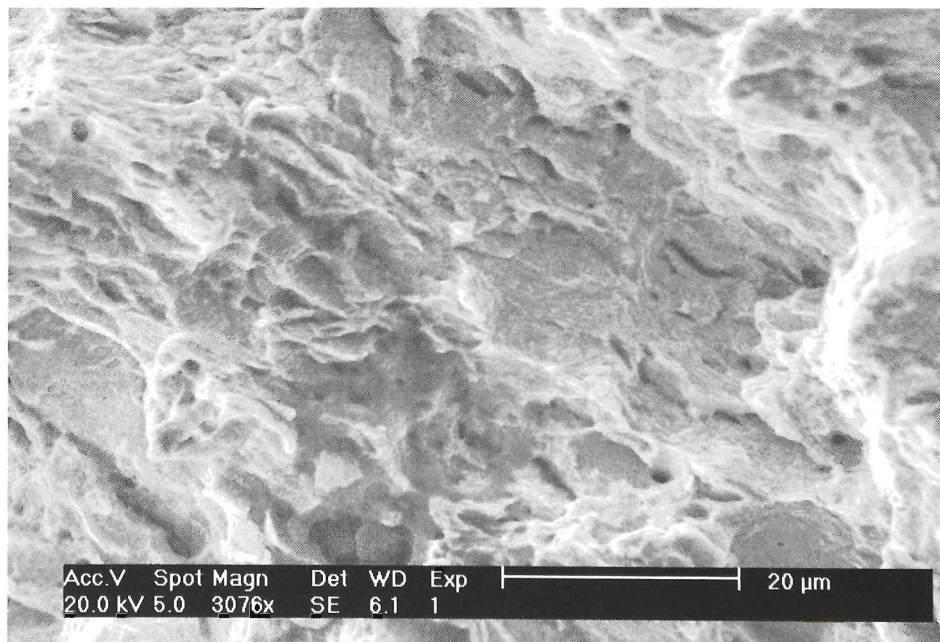
FIGURE 5.39: Non oriented SCC
